U.S. Department
of Transportation
**Federal Aviation
Administration**

Aviation Maintenance Alerts

**ALERT NO. 242
SEPTEMBER 1998**

**Improve Reliability-
Interchange Service
Experience**

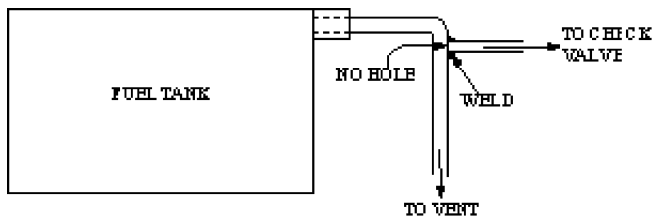
Beech; Model F33A; Bonanza; Improper Fuel Vent Installation; ATA 2810

The technician discovered that the welded tube-tee assembly (P/N 33-921016-1) was not drilled which prevented the fuel tank vent air from reaching the antisiphon check valve.

To solve this problem, the technician drilled a hole at the proper location. (Refer to the following illustration.)

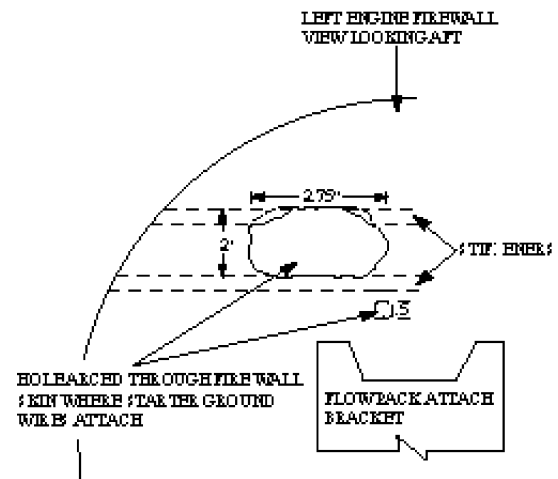
Beech; Model B100; King Air; Engine Starter Failure; ATA 8011

The technician changed the starter. However, even with the installation of the new starter, the engine would not turn. An electrical voltage test revealed the battery supplied 48 volts of electricity to the starter instead of the normal 24 volts. This aircraft design incorporates a feature that allows the selection of a "series start." The "series start" connects two batteries via a relay and delivers 48 volts to the starter for cold-weather operations. The technician inspected the relay located at the start-control panel, and the contacts were arced together. The technician replaced the relay, and the voltage reading at the starter was confirmed to be 24 volts; however, the engine still would not turn.

It appeared that the ground wire bracket became loose where it was attached to the firewall, which resulted in arcing, and the firewall was severely burned. (Refer to the following illustration.)

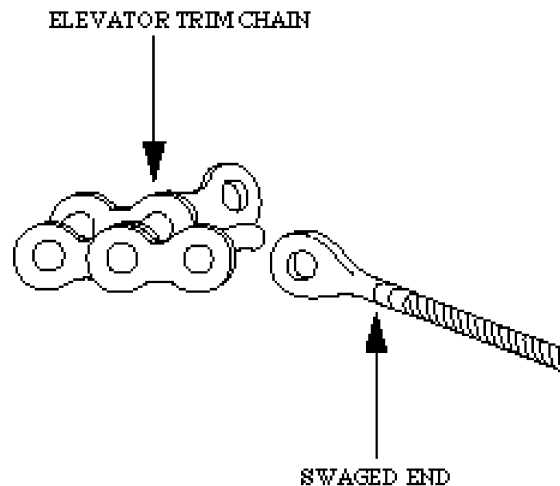
Cessna; Model 182G; Skylane; Elevator Trim System Failure; ATA 2731

Inspecting the elevator trim system chain assembly is difficult because it is located inside the center console; however, the submitter suggested expending extra effort during scheduled inspections.

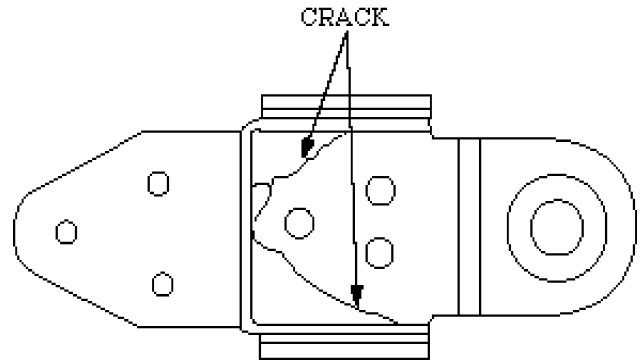
Cessna; Model 310D; Defective Horizontal Stabilizer Mount Bracket; ATA 5510

During an annual inspection, the technician discovered a loose left horizontal stabilizer mount bracket.

The bracket is used as the outboard elevator attachment point. The attachment rivets were loose, and the mount bracket (P/N 0832000-56) was cracked. When the mount bracket was removed, it fell into two pieces. (Refer to the following illustration.)

detect loose and/or fretting rivets. The cause of this defect was not known.

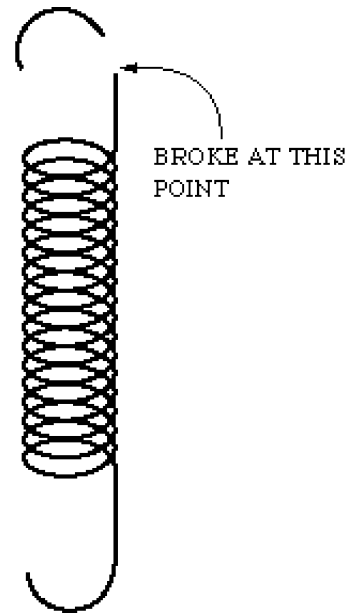
Diamond; Model DA 20A1; Canopy Assist Spring Failure; ATA 5210

The technician found one of the canopy-assist springs (P/N 20-5600-09-02) broken. The spring failed at one end at the point where the radius for the attachment hook begins. (Refer to the following illustration.)

This is the second occurrence of spring failure on this aircraft. It was speculated that there may be a metallurgical problem built into the spring during the manufacturing process.

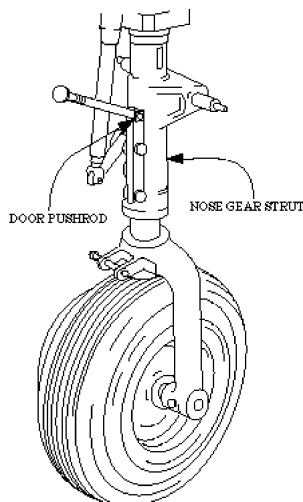
Learjet; Model 35A; Centry III; Improper Installation of Nose Landing Gear Parts; ATA 3230

This report was submitted by a large repair station. The technician found that the nose landing gear door mechanism push-pull rod attachment bolt was not correctly installed.

The submitter suggested that the manufacturer consider issuing written instructions with a "NOTE" or "CAUTION" related to the proper bolt head orientation. The submitter has discovered a total of five occurrences of this defect.

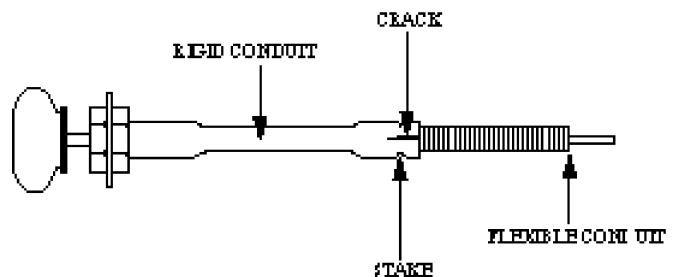
Luscombe; Model 8A; Silvaire; Engine Control Failure; ATA 7603

The technician discovered a crack in the rigid throttle-control conduit. The crack allowed the flexible conduit to separate from the fixed-conduit housing. (Refer to the following illustration.)

The submitter stated this area deserves attention during scheduled inspections.

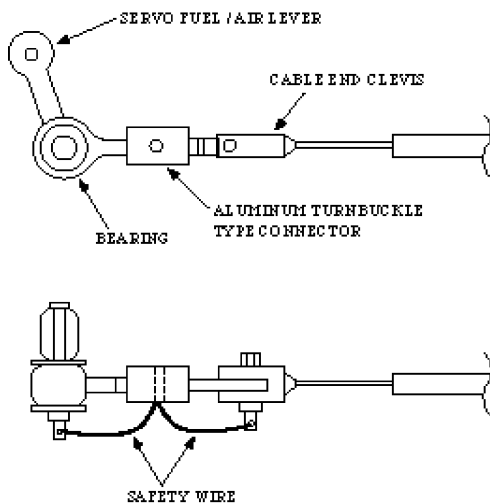
Long-EZ; Model CM-30; Defective Engine Fuel System; ATA 7320

This aircraft incorporated a Textron Lycoming Model IO-360 engine. Following a positive 1-G maneuver, the pilot reported the engine power manifold pressure degraded to 19 inches Hg. The pilot was unable to restore the manifold pressure. The remaining engine power was sufficient to maintain flight, and the pilot

The technician discovered that the fuel injection servo (P/N 2524054) cable clevis end was binding the linkage at the attachment point. (Refer to the following illustration.) The fuel servo markings indicated that it was equipped with a (-9) soft stem which is prone to "hanging up" during positive-G maneuvers. The technician removed the cable clevis end and discovered that the stem was a (-10) hardened type, and the fuel injector servo displayed evidence of corrosion.

After the technician cleaned the servo and installed a new cable clevis end, all the systems functioned correctly.
